# Explosion at Kames Colliery, Ayrshire

on the causes of, and circumstances attending, the Explosion which  
occurred at Kames Colliery, Ayrshire,  
on 19th November, 1957

SIR HAROLD ROBERTS, C.B.E., M.C., B.Sc.

Cmnd. 467

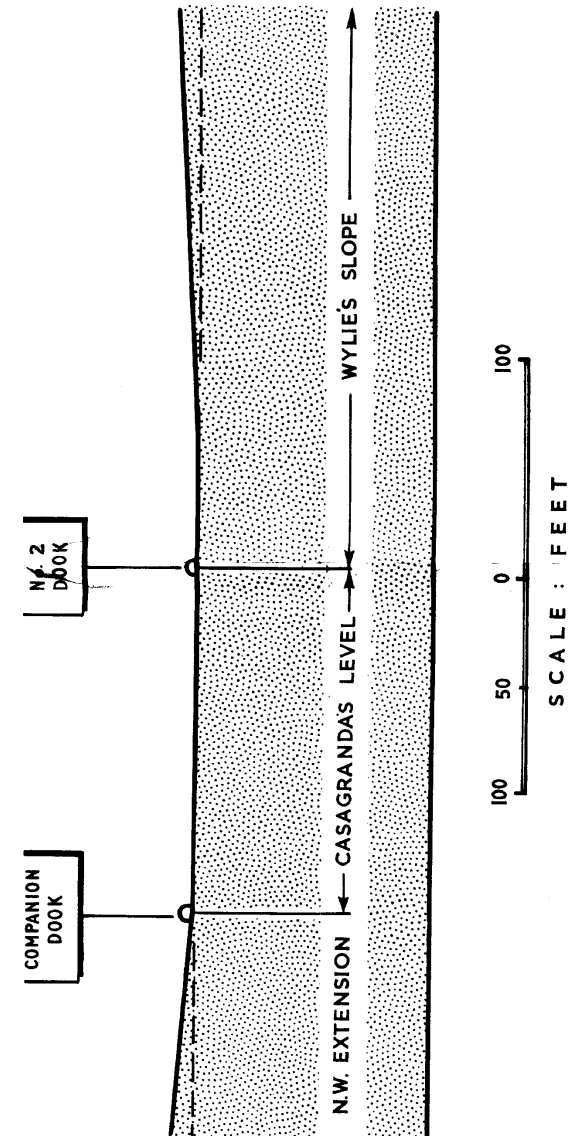
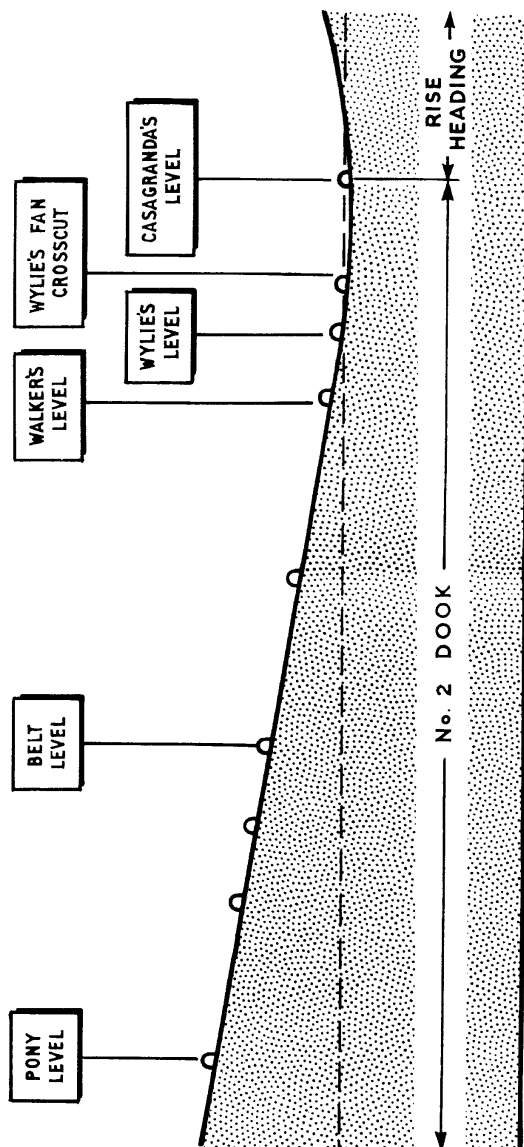
# PLAN No.3

34. As a result of the investigation it was seen that the explosion had spread over almost the whole of the lower workings in the Six Feet Section. The greatest material damage was in the Belt Level and in Walker's Level. There were local falls, mainly at junctions and in disused roads. The extent of flame, the visible signs of coking, and the direction of the spread of the explosion are indicated on Plan No. 3.
